our reference
2-3551

Reference : Gimari bvba / Close2 : **Reference Wheels Close 2** : Carbon rim \pm 50mm – Tubular tyre – 20 Steel spokes length: 255mm – Diameter 2.00mm – Total weight tires included 0.950kg

Company : Gimari

CONCERNING : IMPACT TEST ON BICYCLE WHEELS

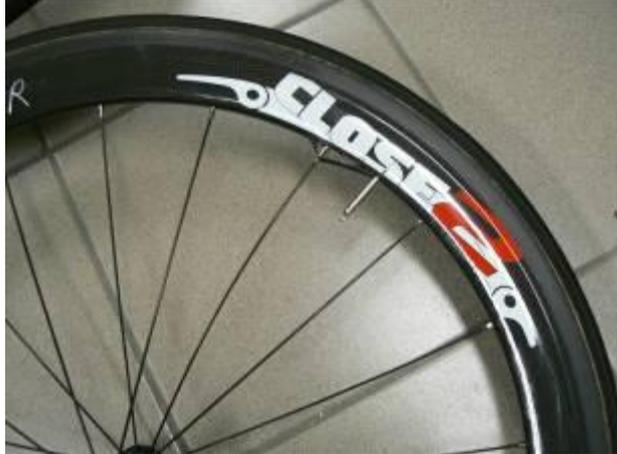
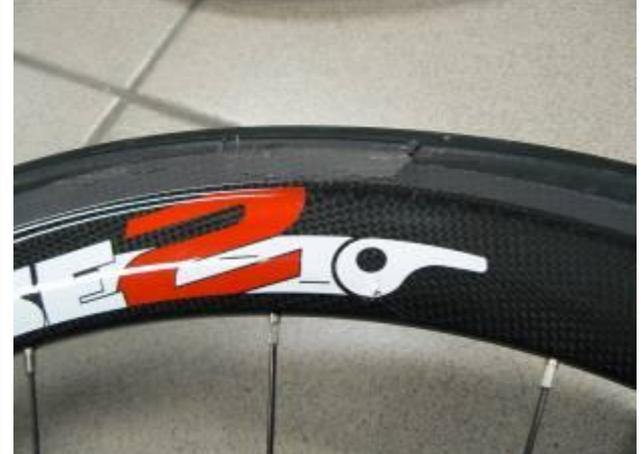
Front position

<p>The rim is crushed. The carbon part presents some cracks and failures on the height of the rim.</p>	<p>The rim is crushed. The carbon part presents some cracks along the rim.</p>

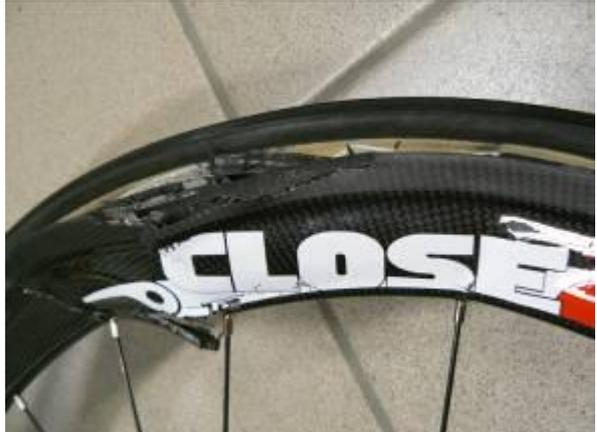
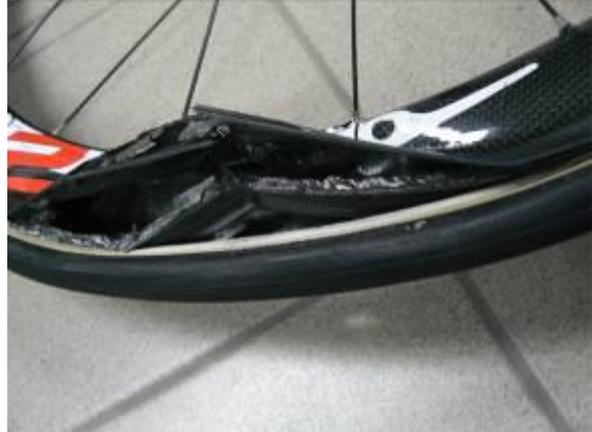
Results : Edge position

<p>The rim is crushed. The carbon part does not present any opening. The different carbon layers stay bonded together.</p>	<p>The rim is crushed. The carbon part does not present any opening. The different carbon layers stay bonded together.</p>
