our reference
2-3551

Reference : Gimari bvba / Close2 : **Reference Wheels Close 2** : Carbon rim \pm 50mm – Tubular tyre – 20 Steel spokes length: 255mm – Diameter 2.00mm – Total weight tires included 0.950kg

Company : Gimari

CONCERNING : IMPACT TEST ON BICYCLE WHEELS

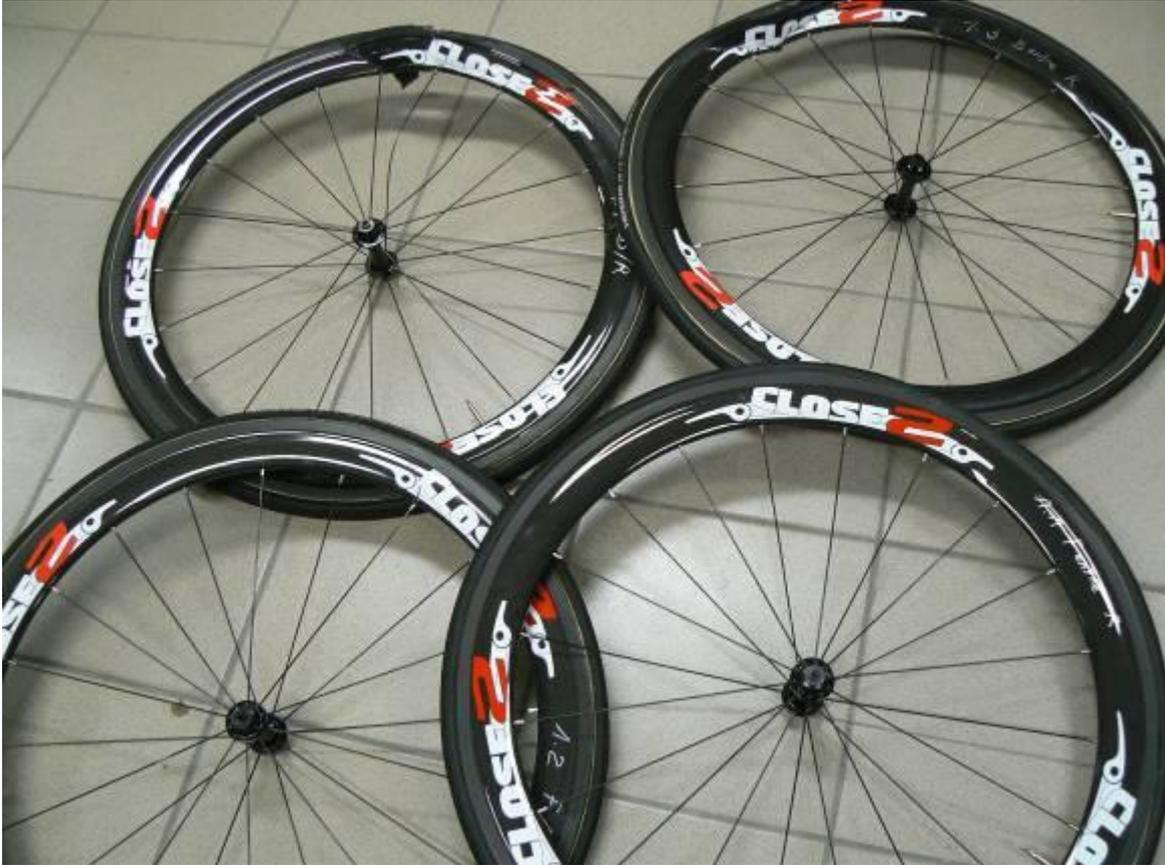
<p>The rim is crushed. The carbon part presents some cracks and failures on the height of the rim.</p>	<p>The rim is crushed. The carbon part presents some cracks along the rim.</p>
